Drones as a tool for the sustainable conservation of heritage metal Structures

Rubén Rodríguez Elizalde

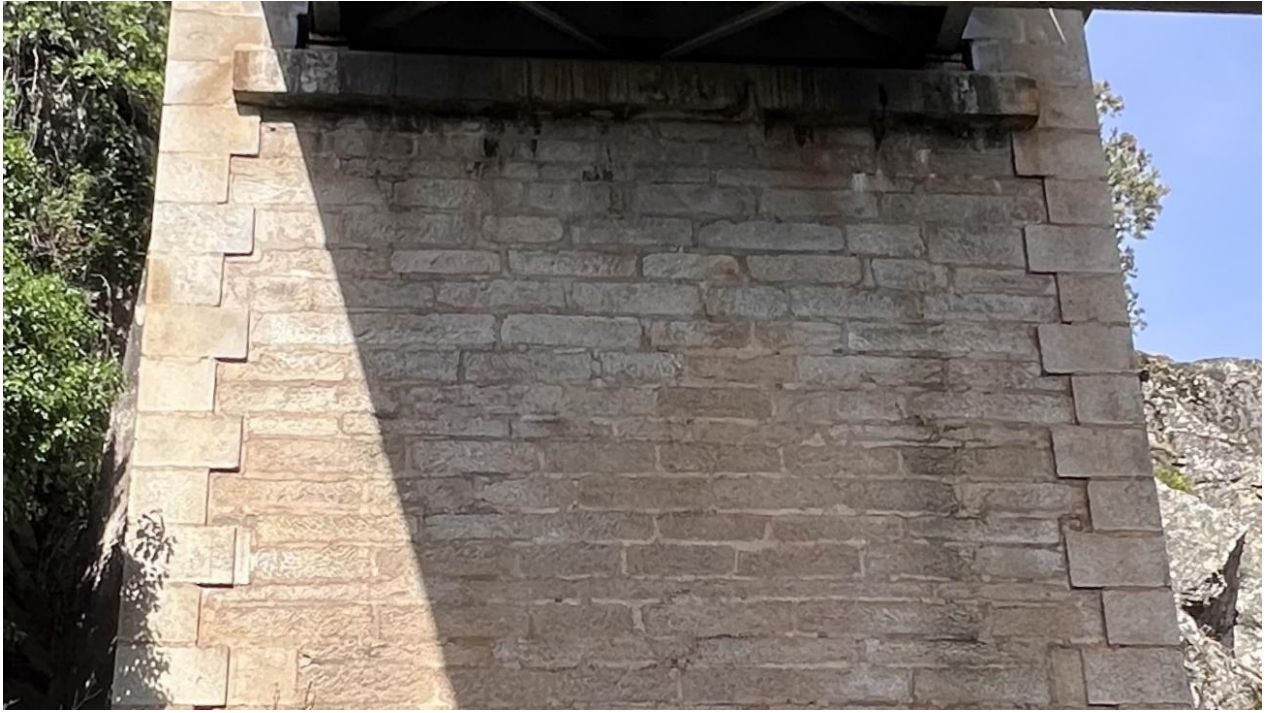
Previous observations (Figure 9) had already indicated that, despite its century-old age, the concrete foundation elements presented a generally acceptable state of conservation, showing slight deterioration related to the material's durability, particularly due to runoff water. The action of runoff water was also the primary pathology observed on the abutment walls, where stains associated with moisture caused by the continuous process of surface runoff sliding down the wall face were detected (Figure 13).

Figure 13.
Wall of the second abutment with runoff water traces.

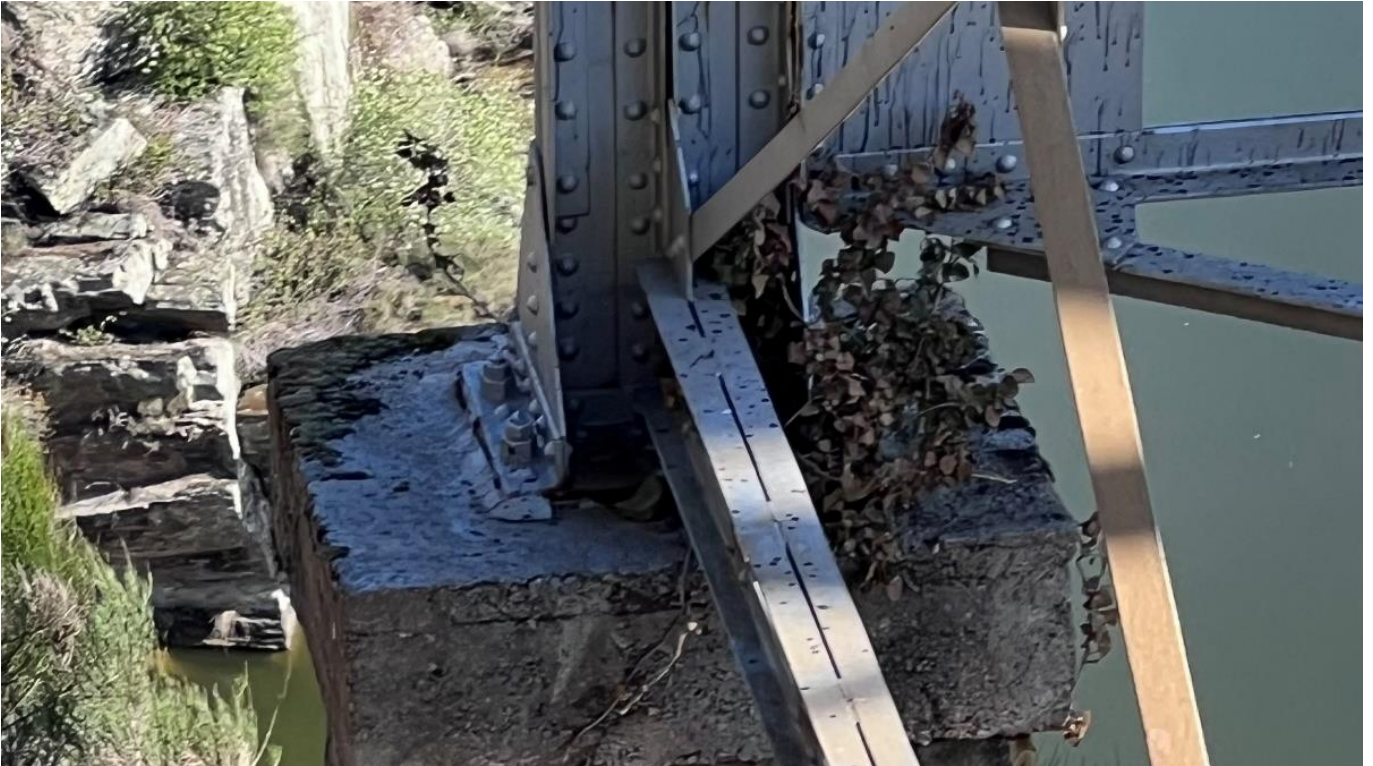
Vegetation and organic matter, primarily moss, were found on some of the support footings of the sheet pile walls, with the sixth sheet pile, near the second abutment, being particularly affected (Figure 14). The presence of vegetation on concrete elements always indicates suboptimal maintenance. Deterioration of concrete caused by vegetation constitutes a form of chemical attack induced by living organisms. In the case of higher plants, this effect combines both mechanical and chemical actions, as roots exert pressure on joints or cracks where they take hold, while simultaneously retaining moisture, thereby exacerbating the damage.

Figure 14.
Presence of organic matter and vegetation on the concrete footing of sheet pile wall 6, downstream side.

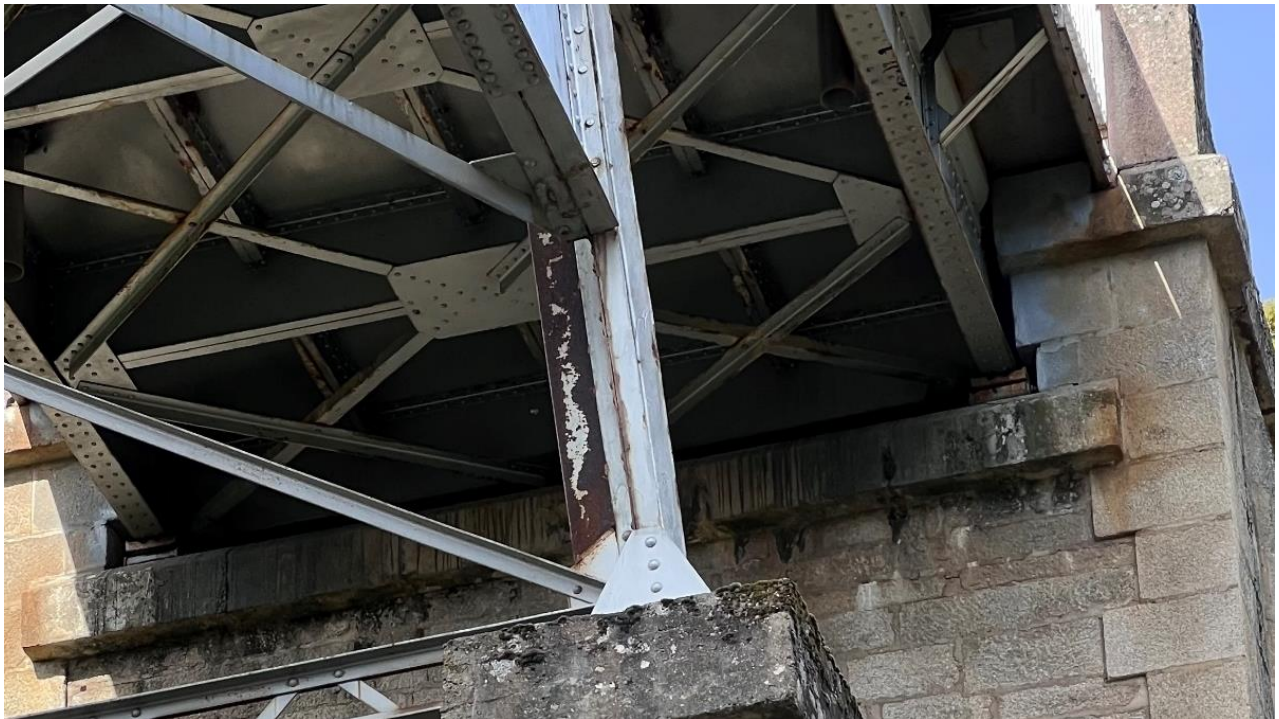
The sheet pile walls exhibited widespread deterioration of the corrosion protection system. This damage was more severe on the end walls: the first sheet pile wall on the downstream side and the seventh sheet pile wall, also on the downstream side (Figure 15). Additionally, localized corrosion of components was observed at the ends of the sheet piles, attributed to the tendency of these areas to accumulate moisture.

Figure 15.
Corrosion on sheet pile wall number 7, the one closest to the second abutment, downstream side.

Notably, the transverse beams at the ends of the deck, over the abutments, displayed significant corrosion on the face closest to the abutment guard wall (Figure 13 and Figure 15).

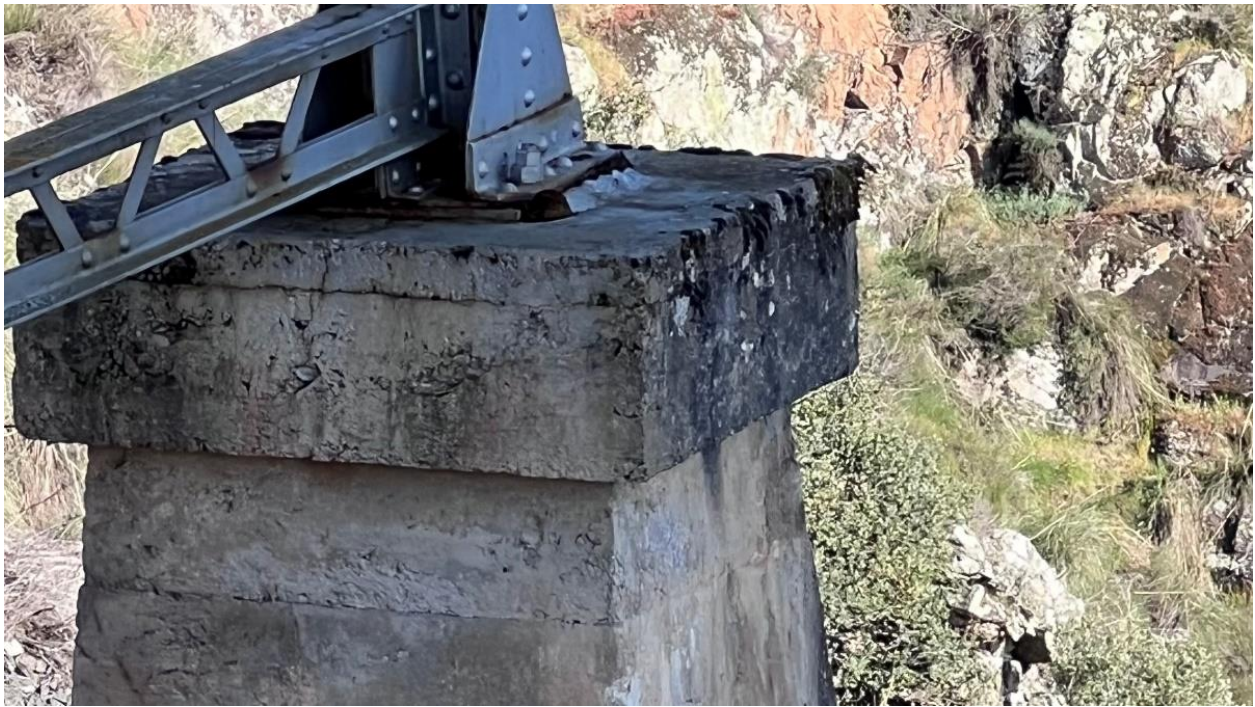
In the case of the last sheet pile wall, the seventh one, the drone inspection revealed the loss of the head of one of the anchor bars on the downstream support (Figure 16). This loss appeared to be linked to the corrosion present on the bar, which likely caused its eventual breakage.

Figure 16.
Loss of an anchor head on sheet pile wall 7, downstream side.

Some of the observed corrosion may have originated from leaks in the deck before its repair and replacement in 2013, meaning such issues might not recur. An additional consequence of corrosion is the loss of the head of one of the four anchor bars of the last pier at its downstream end.

Based on the observations, it is deemed appropriate to equip the structure with a new protection system that will offer corrosion resistance for at least another 25 years. Before this, localized repairs should be made to the observed defects and deterioration, with particular attention given to cleaning and preparing corroded areas. This will ensure that the new protection system has a proper base, preventing premature failure before reaching its full-service life. In other words, both preventive actions to halt the progression of corrosion and remedial actions to repair some metallic elements are proposed. Examples include installing a new anchor bar in Pier 7 and replacing stiffeners in railings.

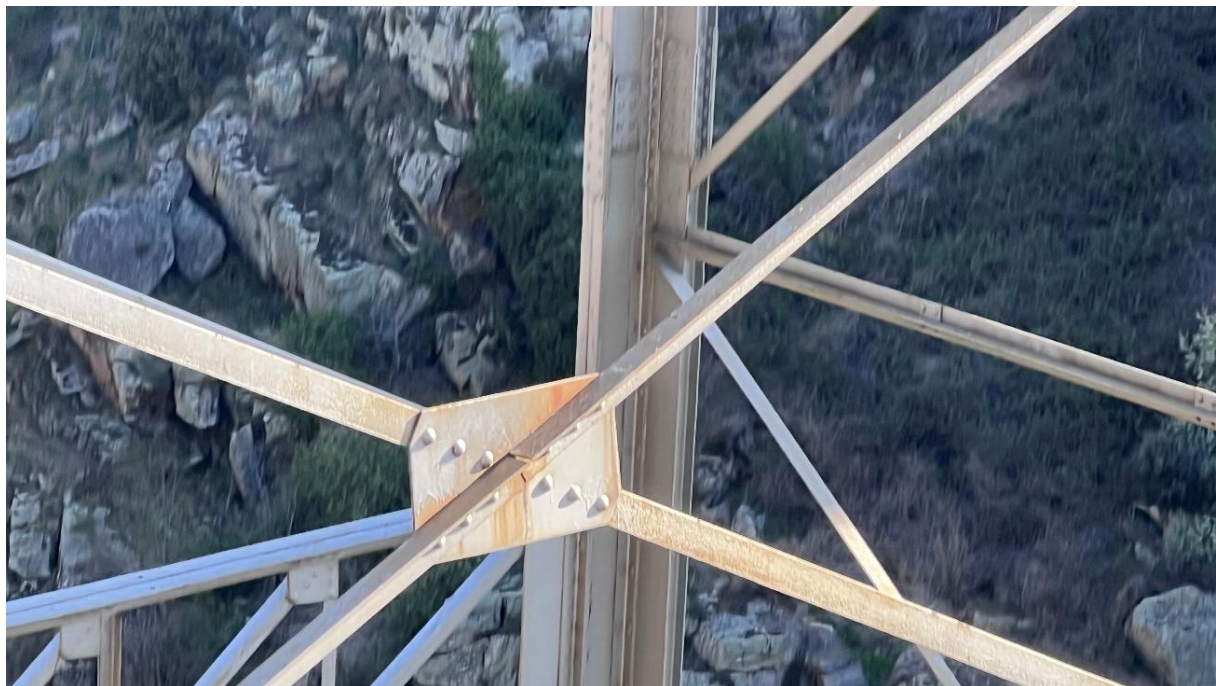
The analysis of the ends concluded with the detection of localized corrosion on some of the braces, which was more pronounced near the second abutment (Figure 17). This deterioration is undoubtedly the result of the combined action of atmospheric oxygen and humidity, exacerbated by the lack of an adequate protective surface treatment on the metal elements.

Figure 17.
Localized corrosion on one of the braces of the sheet pile walls at the western end of the bridge, upstream side.

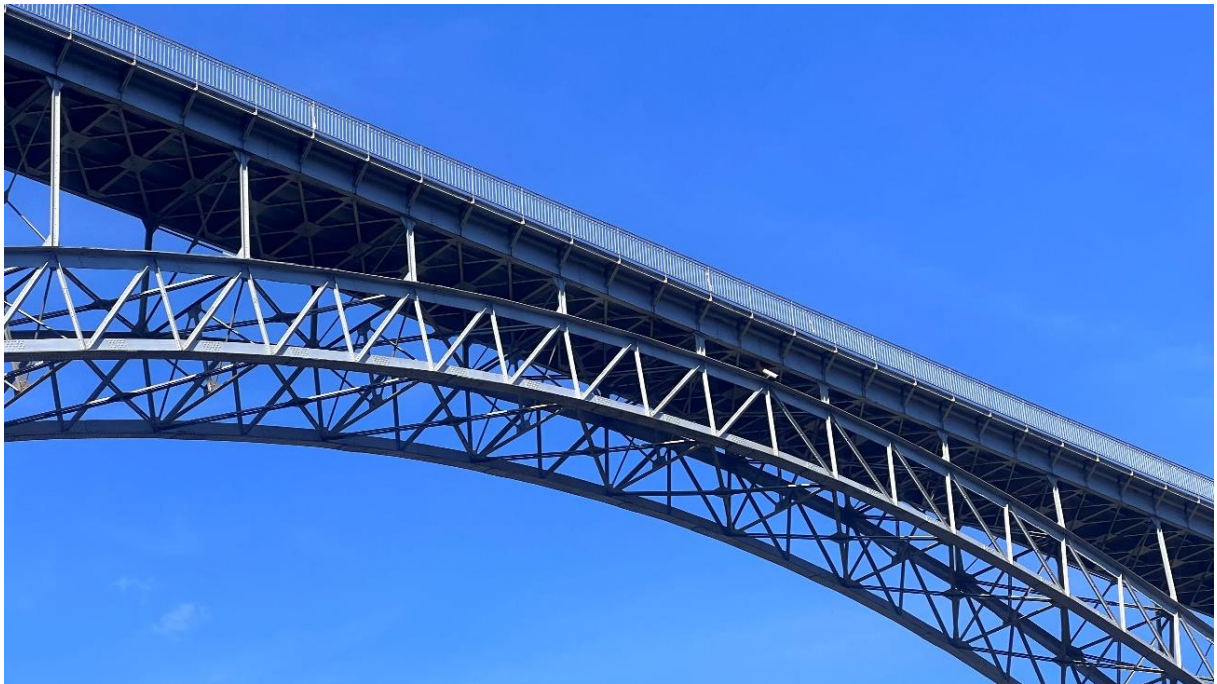
Figure 18.
Bottom view of the arch from the downstream side.

Stains produced by the discharge of water and other liquids through the drainpipes were also observed. At the time of the visit, these pipes were not long enough to discharge water away from the arch (a pipe can be seen in the center of the arch in Figure 8 and Figure 18).

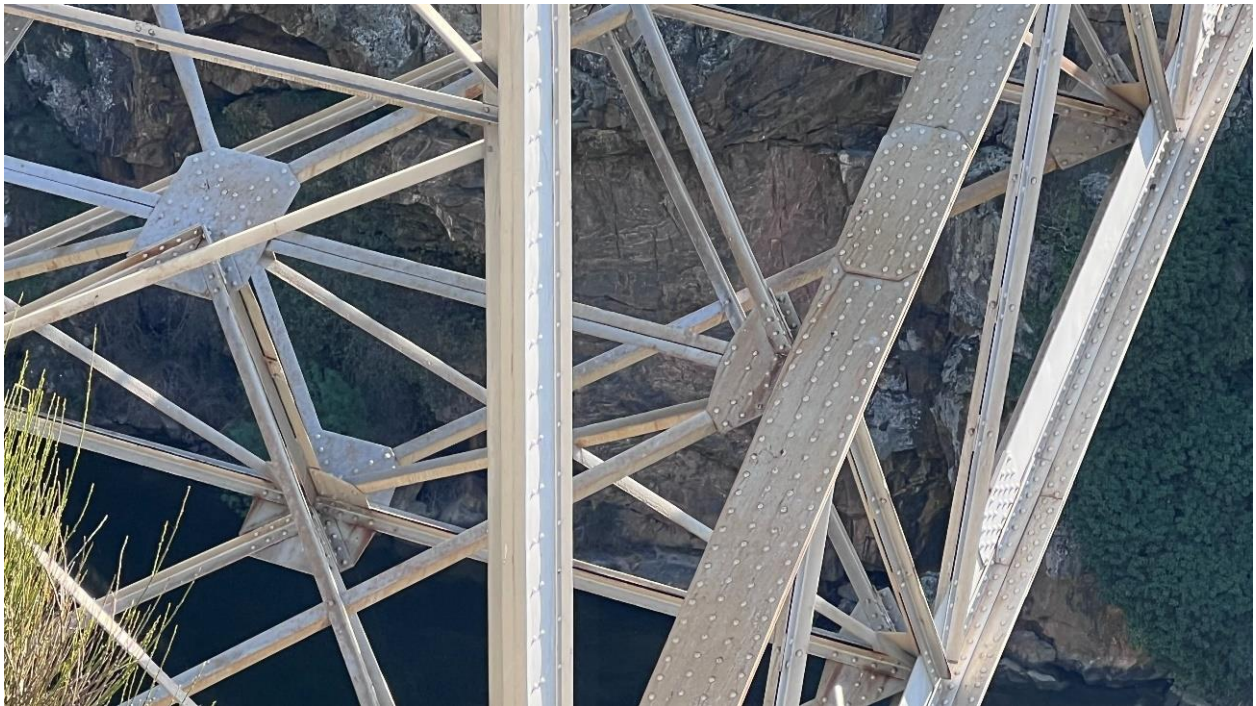
During the inspection, the arch only showed deterioration due to the aging of the corrosion protection system (Figure 19), with patches of rust visible on the upper part of the heads of the lateral beams forming the arch, as well as localized rust at connection points between elements (Figure 20).

Figure 19.
General state of the arch, in a section between support uprights.

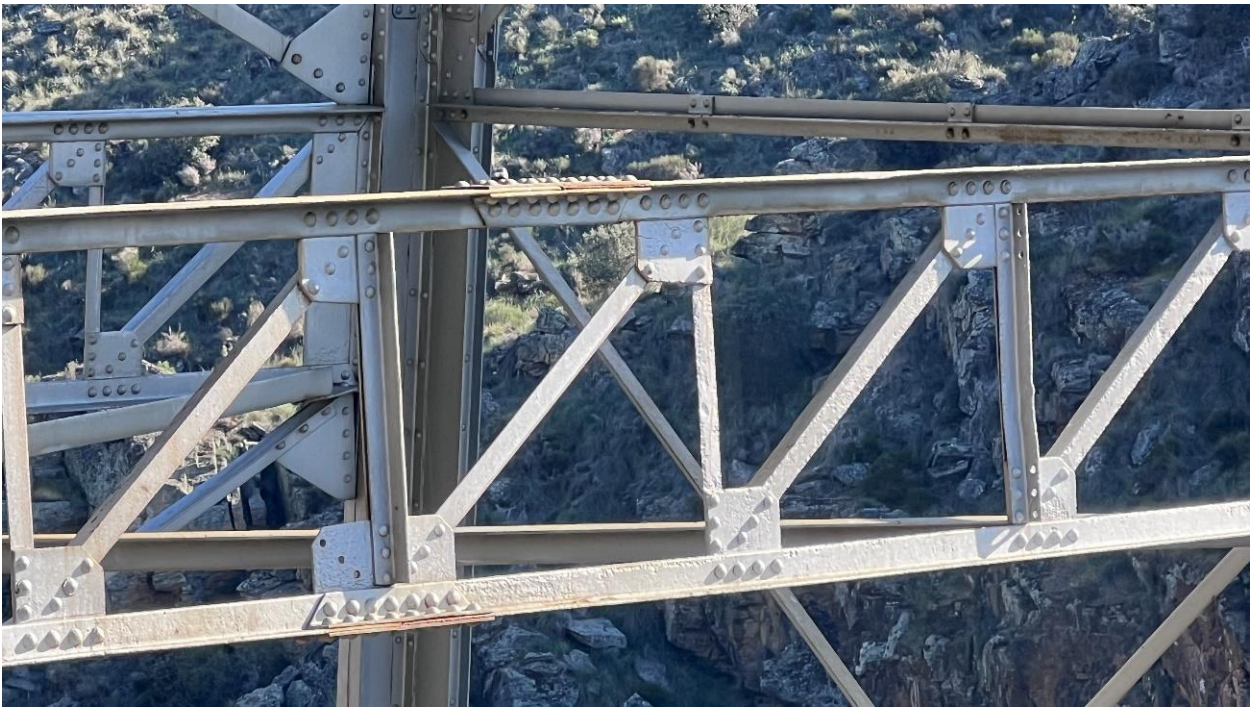
Figure 20.
Detailed view of an arch section with localized corrosion at connection points.

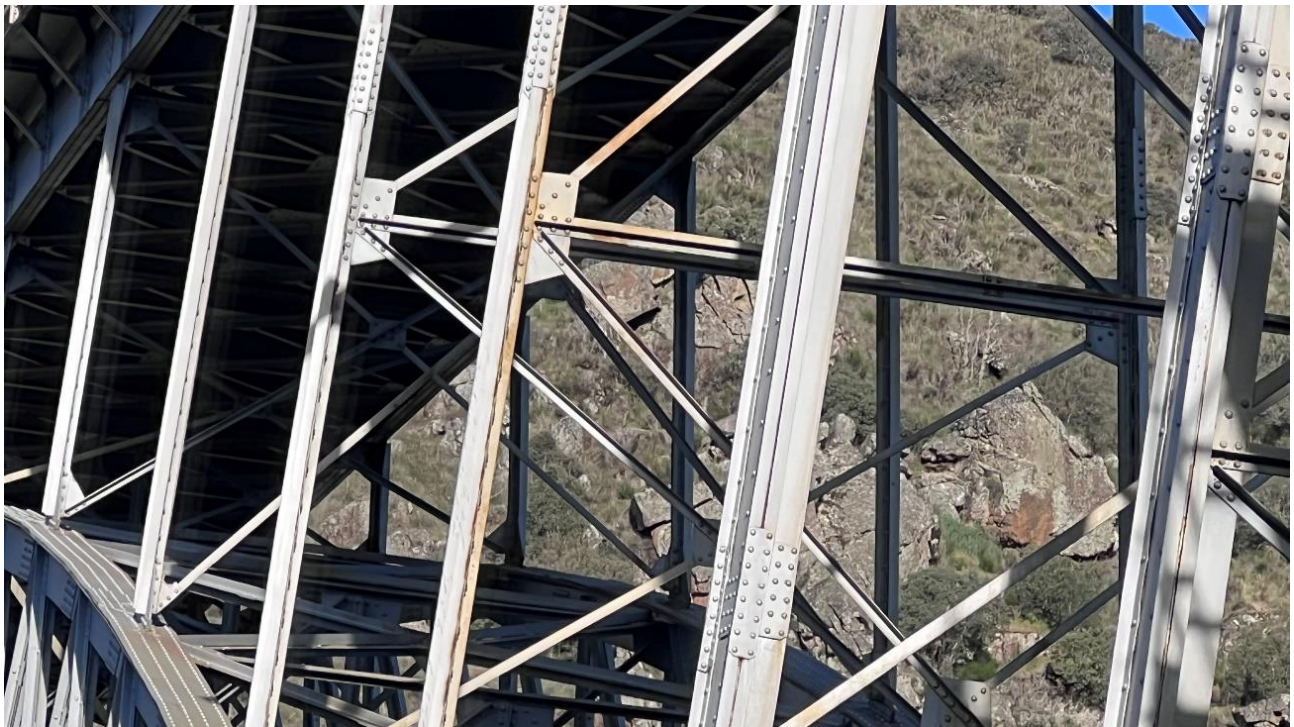
The uprights on the arch exhibited widespread deterioration of the corrosion protection system due to aging. Corrosion spots were observed between elements comprising the uprights, such as plates and L-shaped profiles (Figure 21).

Figure 21.
Detail of corrosion on one of the uprights over the arch.

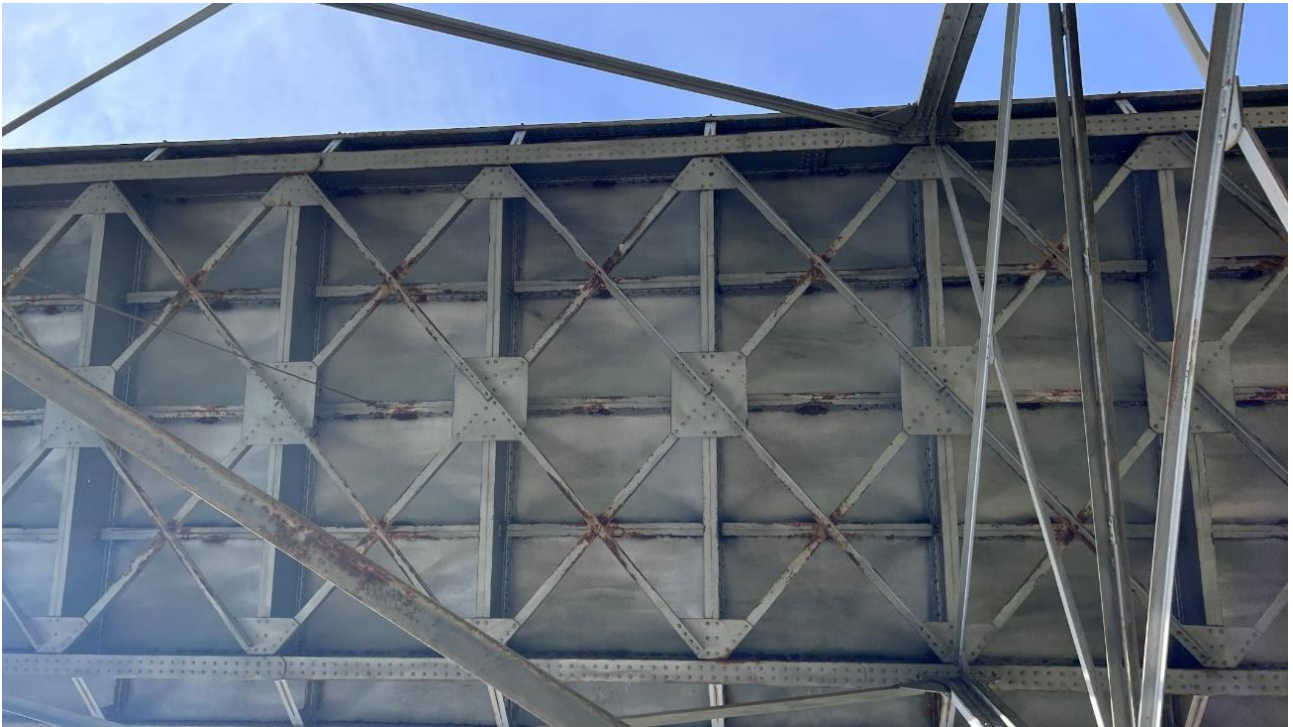
Atop the arch lay the deck, which also exhibited localized corrosion at numerous points along its entire length and width (Figure 22). A closer examination confirmed that corrosion was particularly concentrated at the connections between stringers and the slab, as well as at the connections between transverse beams and the X-shaped cross braces (Figure 23).

Figure 22.
Bottom view of a deck section, showing numerous elements with localized corrosion symptoms (photograph by the author, taken with a drone).

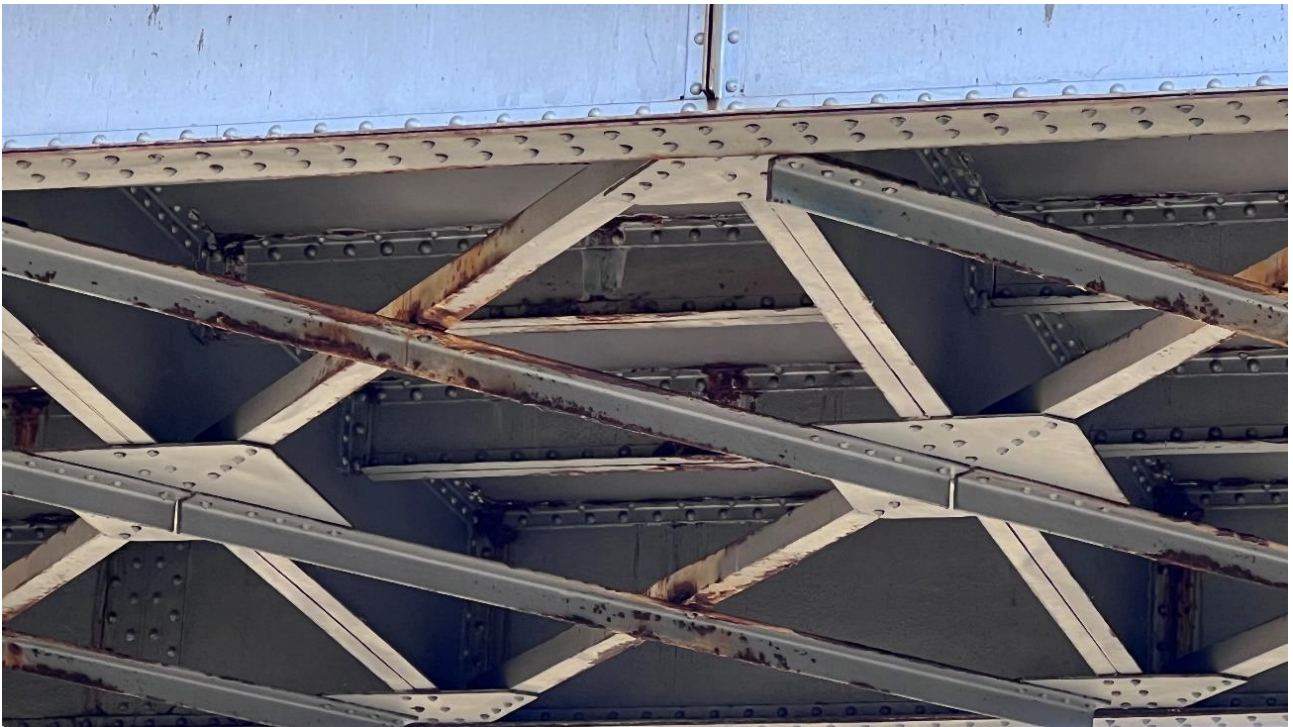
Figure 23.
Detailed view of a deck section with localized corrosion on several elements.

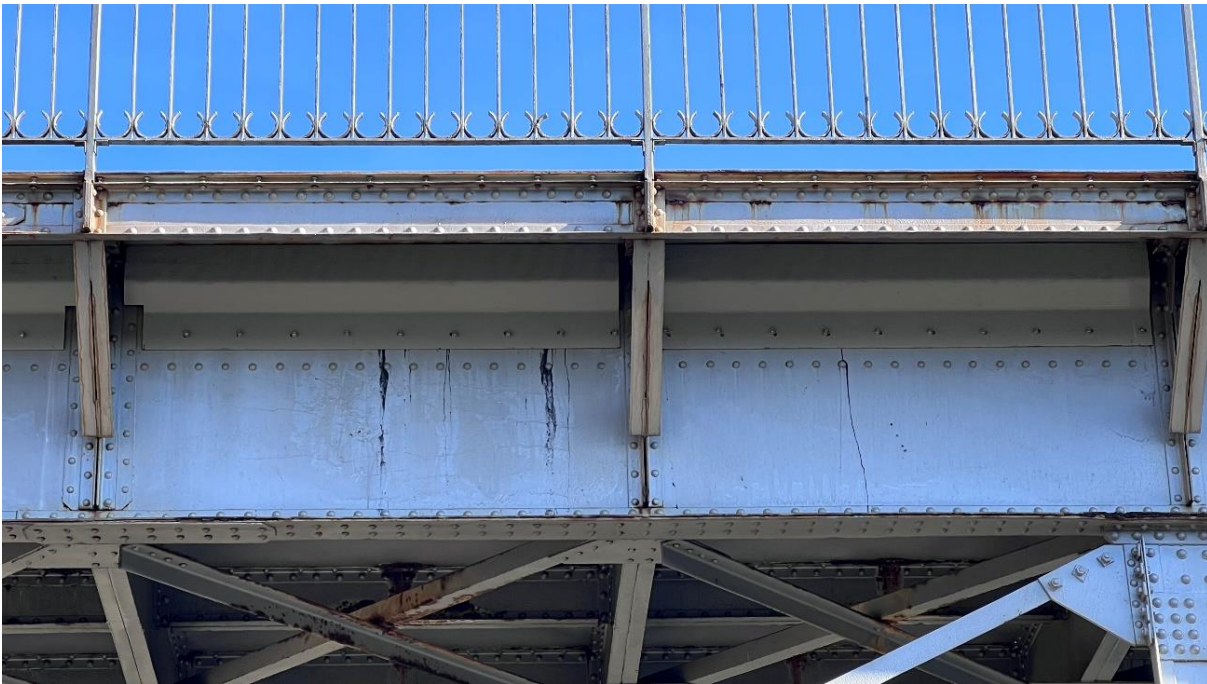
Finally, the cantilevered walkways, formed by metal plates supported on metal brackets, were also subject to corrosion (Figure 24), with traces of rust and stained runoff water visible on all elements.

Figure 24.
View of the cornice and the underside of the perimeter protective railing.

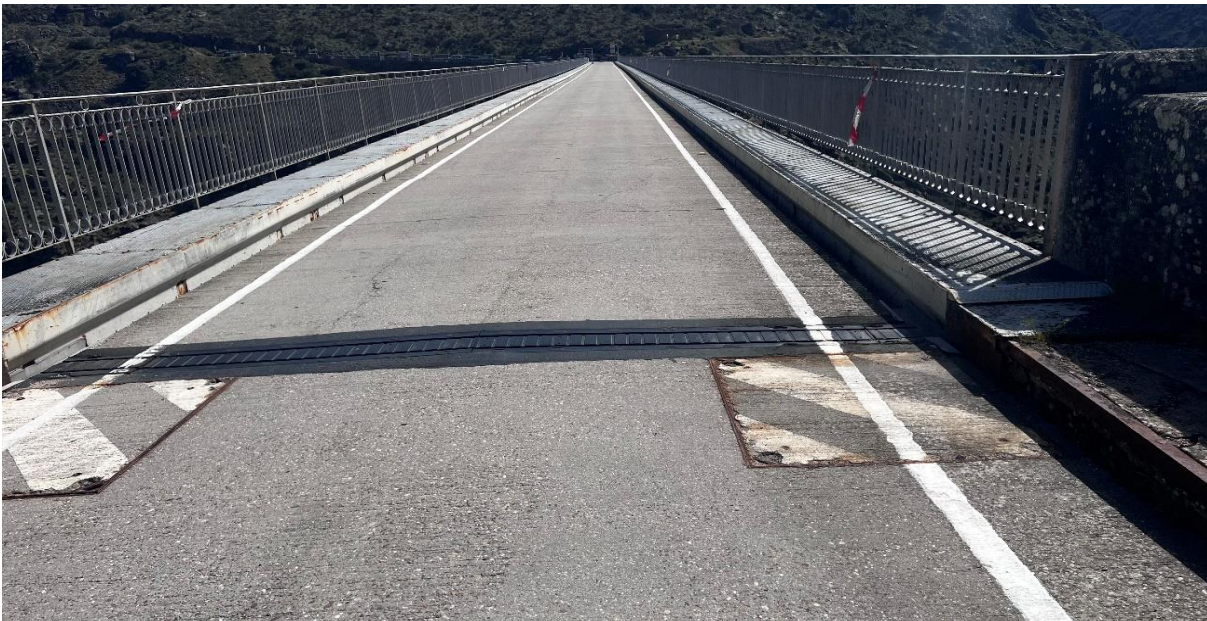
On the platform, corrosion was detected on the railings and walkways (Figure 25), along with localized deformation of the handrails on both railings, caused by the loss or theft of cylindrical stiffeners and, in some cases, the detachment of the crowning curb. Additionally, slight deterioration of the joints due to aging, as well as corrosion of the metal planters on the four access sidewalks to the structure, was observed (Figure 25).

Figure 25.
View of the road platform above, taken from the second abutment.
