## Development of an intelligent geographic information system for mountain roads monitoring: Ground data collection and analysis

This study examines the development of an intelligent geographic information system for mountain road monitoring. To make well-informed and timely management decisions in the planning, construction, and maintenance of mountain roads, and to anticipate potential critical situations and their effects on road conditions, it is imperative to employ modern methodologies. This study involves data collection from a specific section of a mountain road situated near Almaty, Kazakhstan. We gathered data on the road section through visual assessment, measurements of the coefficient of adhesion, and the acquisition of material samples from the structural layers of the roadbed. Based on the visual assessment and surface adhesion measurements, it became evident that the deformation of the studied road section, which includes a network of cracks and "non-standard" transverse cracks, is attributed to mountain mass shifts and water flows from slopes. Laboratory analysis of the collected samples revealed that excessive water saturation could result in cracks during freez

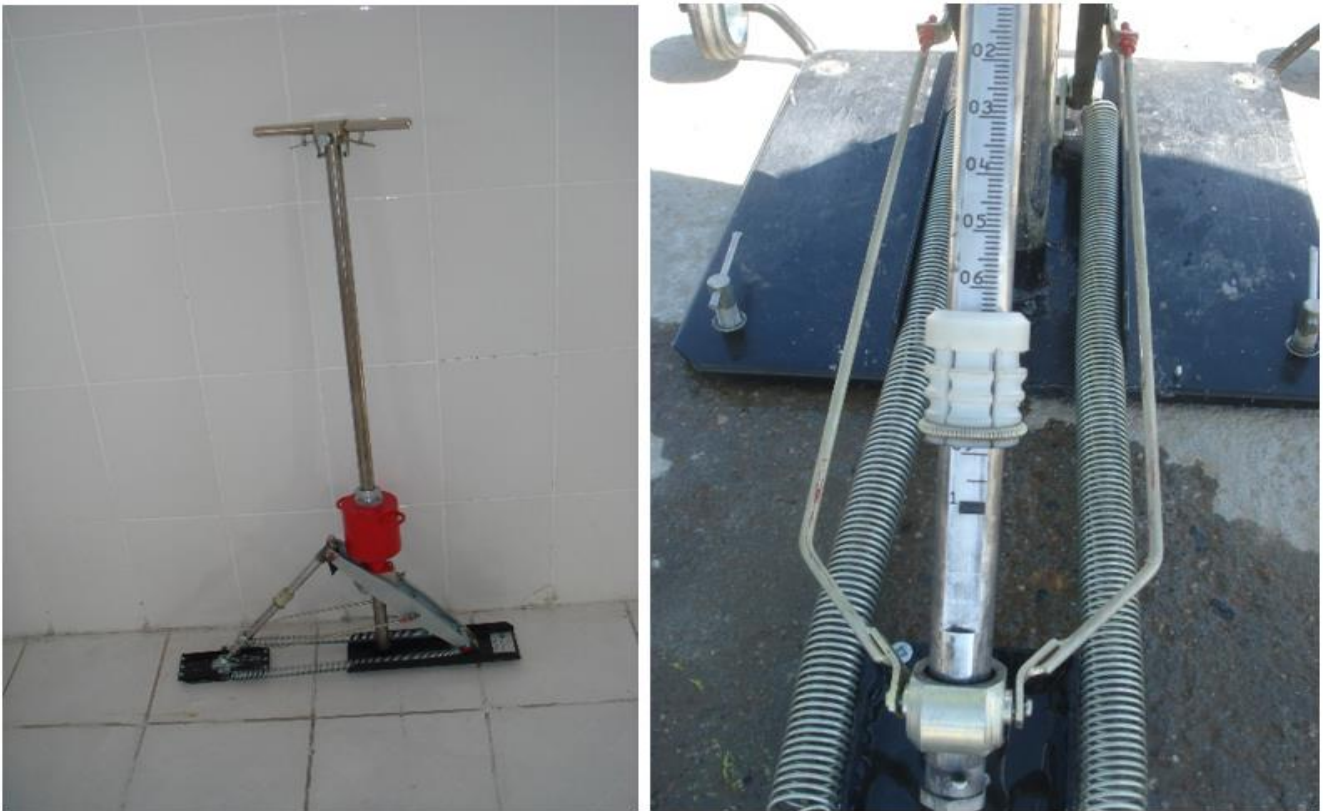
**Figure 4.**  
Portable device for measuring the friction coefficient named IKSp-M and the measurement process.

Portable devices named IKSp-M are utilized for the selective measurement of the coefficient of adhesion values on road sections. Measurement requirements are:

- From 2 to 6 measurements per 1 kilometer of road;
- The left lane of each carriageway;
- On an artificially moistened surface;
- At an ambient temperature of about +20°C;
- Not during rain and not within 2-3 hours after precipitation.

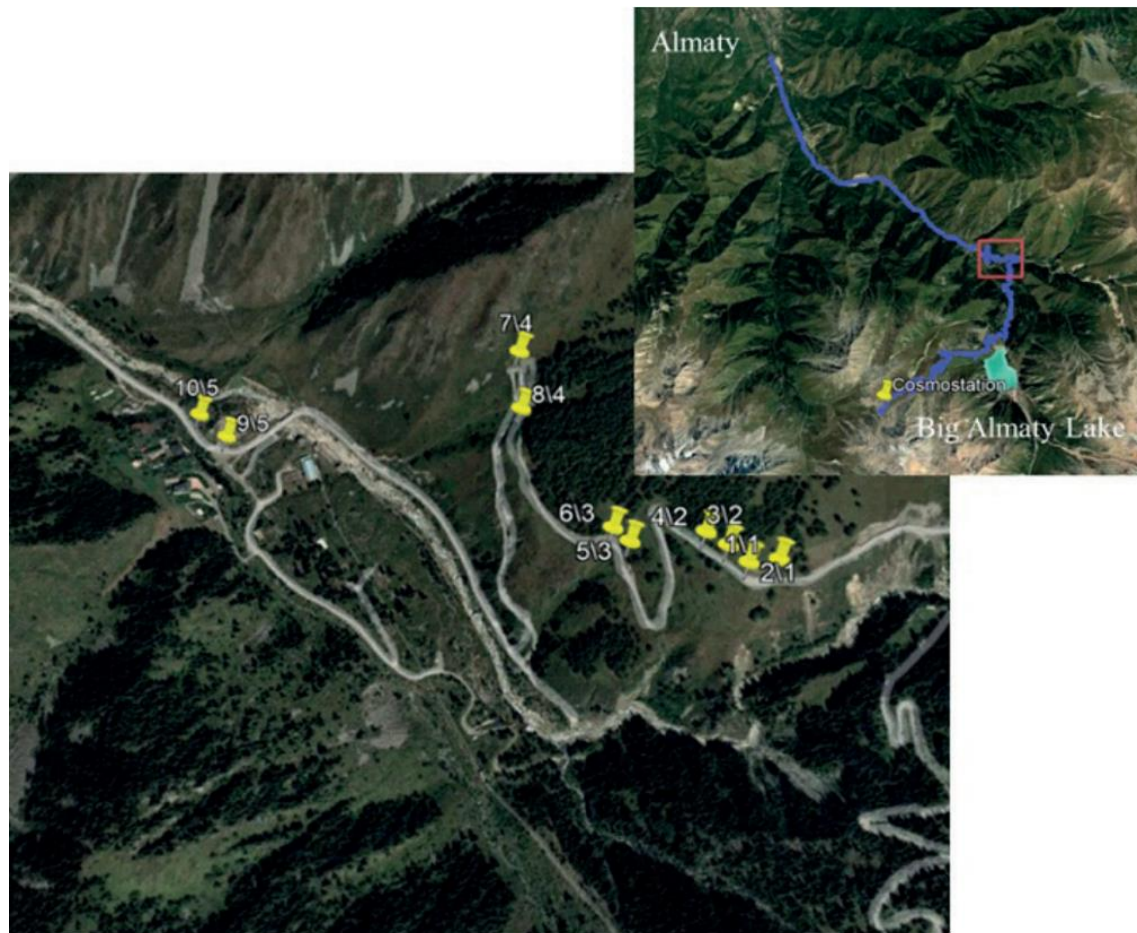
**Figure 5.**

To assess the strength properties of pavements, studies were conducted on five sections, each measuring 50 meters in length, along the Almaty-Kosmostation highway, as illustrated in Figure 5, which contains the coordinates for the beginnings and ends of each section and their yellow marks [29].

The testing sections on the Almaty-Kosmostation road.

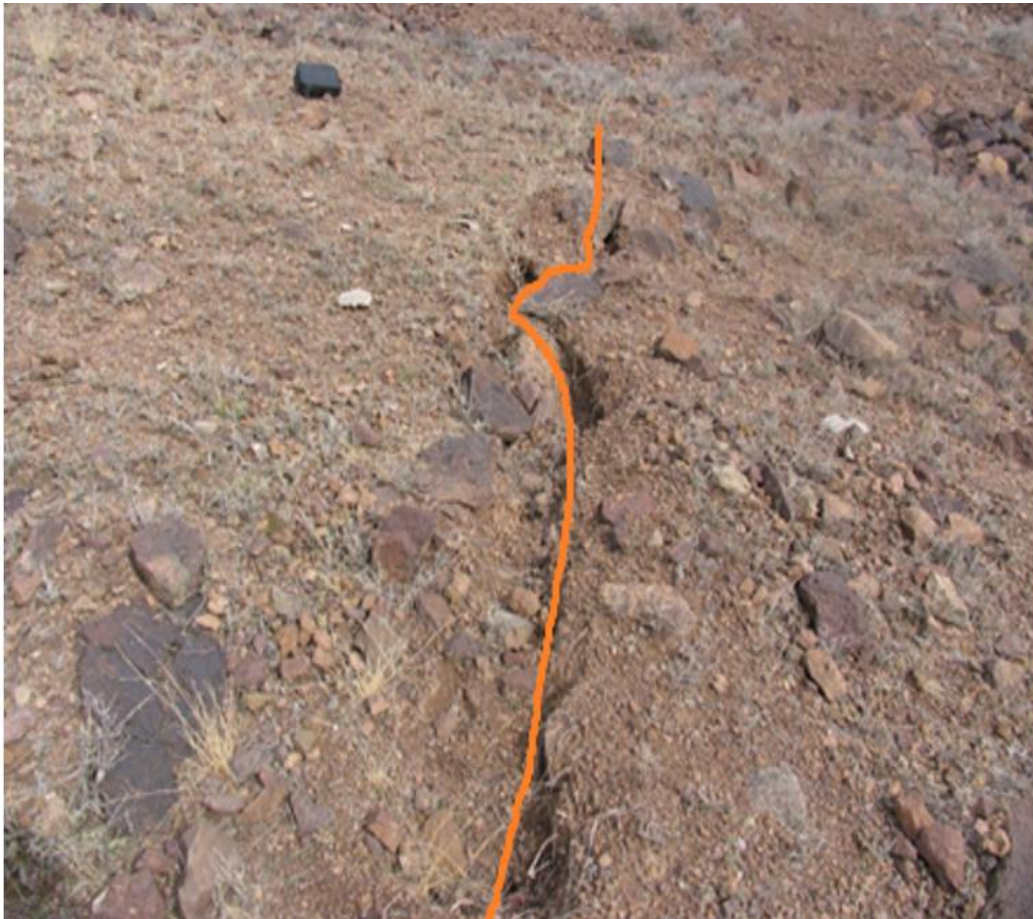
Several factors contribute to the swelling of roadways. Firstly, the landslide body, resting on the bedrock crossbar close to the landslide's "tongue," exerts pressure that contributes to the upward displacement of the roadbed. Secondly, the presence of water in the vicinity of the roadbed, which undergoes freezing and thawing cycles, also plays a role in this phenomenon. Furthermore, in the upper northeast region of the landslide body, secondary cracks have initiated (Figure 6). Notably, the primary slide crack, formed several years ago (5-10 years) (Figure 7), continues to expand gradually.

**Figure 6.**  
Second-order tensile crack.

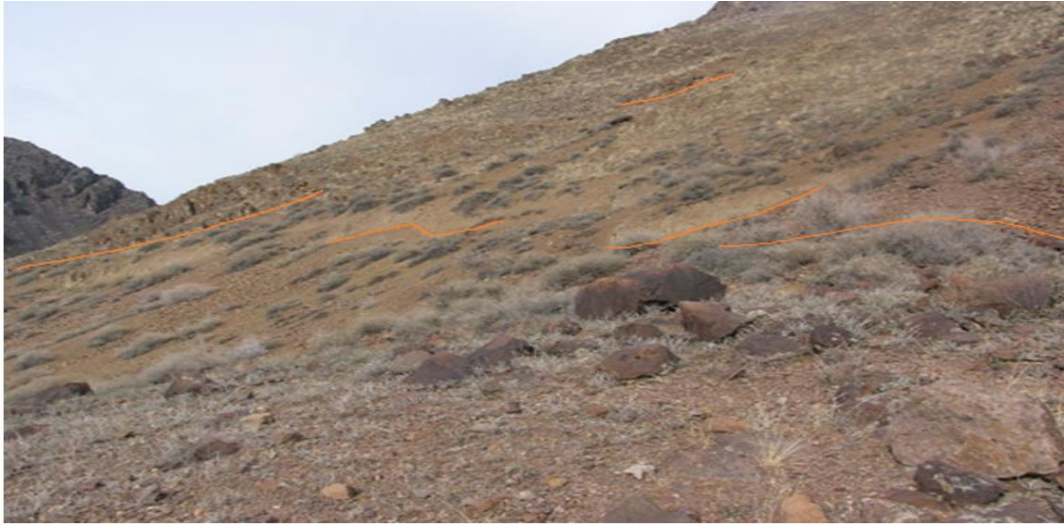
**Figure 7.**  
Sliding cracks.

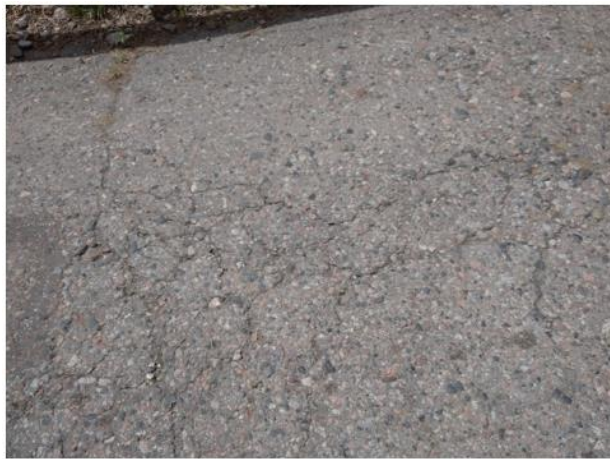
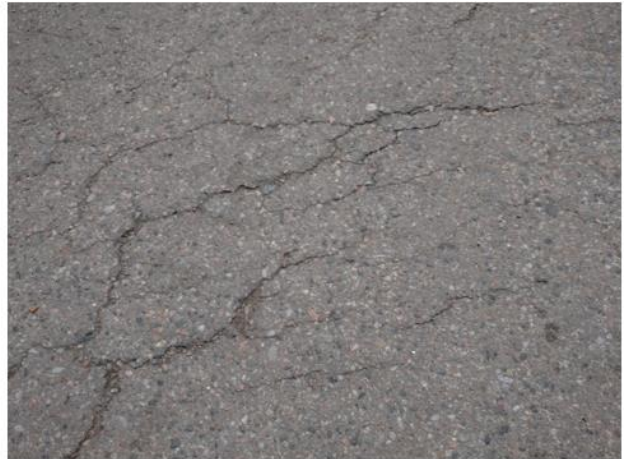
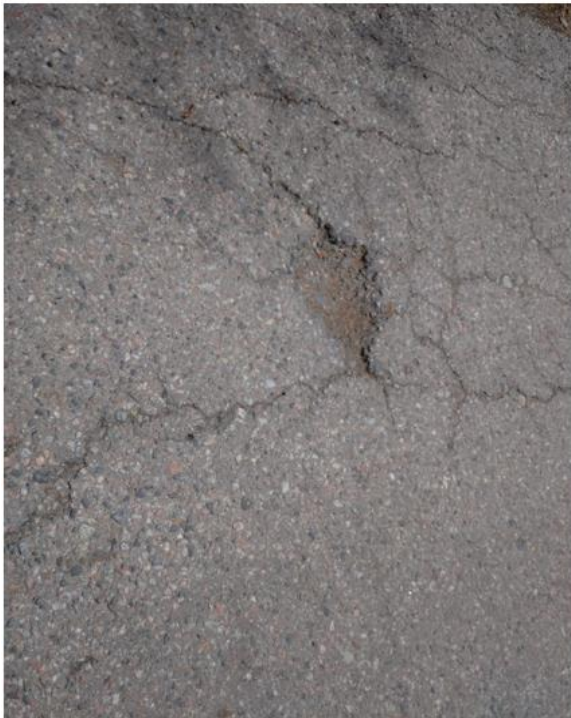
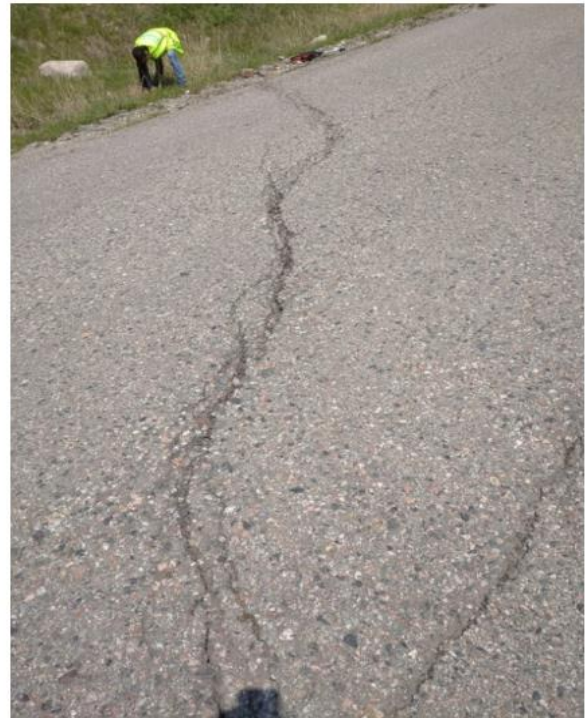
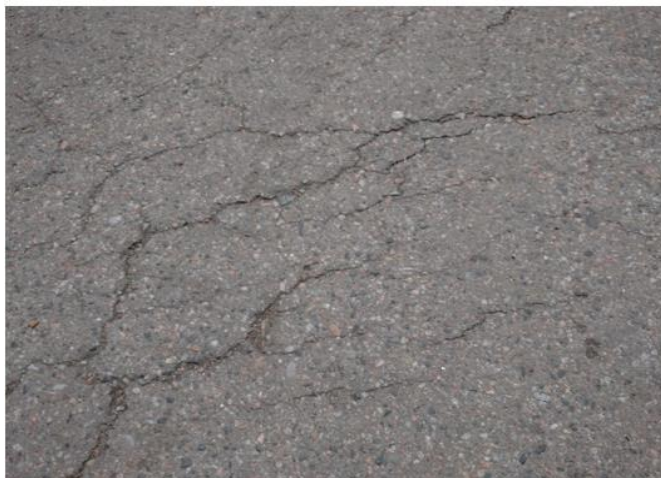
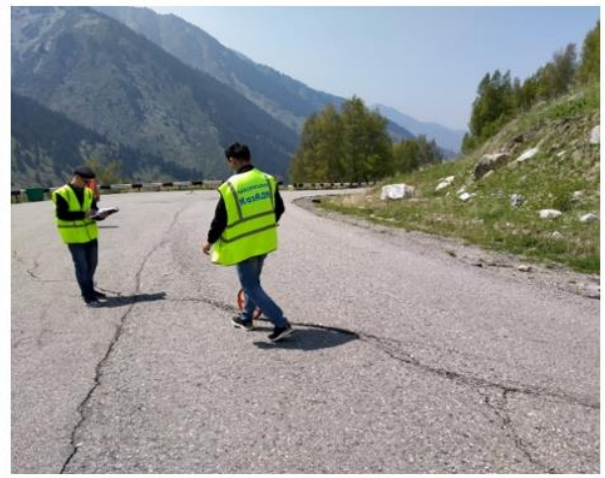
**Figure 10.**

Figure 10 illustrates the road damage that is characteristic of all segments of this road, signaling the onset of roadway deterioration. The sharp increase in the number of transverse cracks and the emergence of deep transverse and longitudinal cracks in site No. 2 can be attributed to the presence of sandy soils on the mountain slopes along this section (Figure 11). At site No. 3, the formation of transverse cracks exhibits a distinct pattern, particularly in terms of their length. Furthermore, this region has experienced noticeable slope erosion (Figure 12), with erosion levels increasing annually. Site No. 4 displays a different configuration in the development of longitudinal cracks (Figure 13). These longitudinal cracks do not align with the road axis or the travel lanes of the roadway; instead, they resemble deep, prominent lines. Numerous smaller crack lines coalesce to form a complex network of longitudinal cracks, positioned along the edge of the pavement. Despite the relatively short service life of newly constructed site No.5, which has been in operation since 2021, various types of cracks have already appeared on the surface of the pavement (Figure 14).

Small (Starting) (a) and medium (b) crack grids, the formation of small holes in the middle of the crack grid (c), deep (Reflected) transverse cracks (d), multi-branch transverse cracks (e) and longitudinal cracks (f).

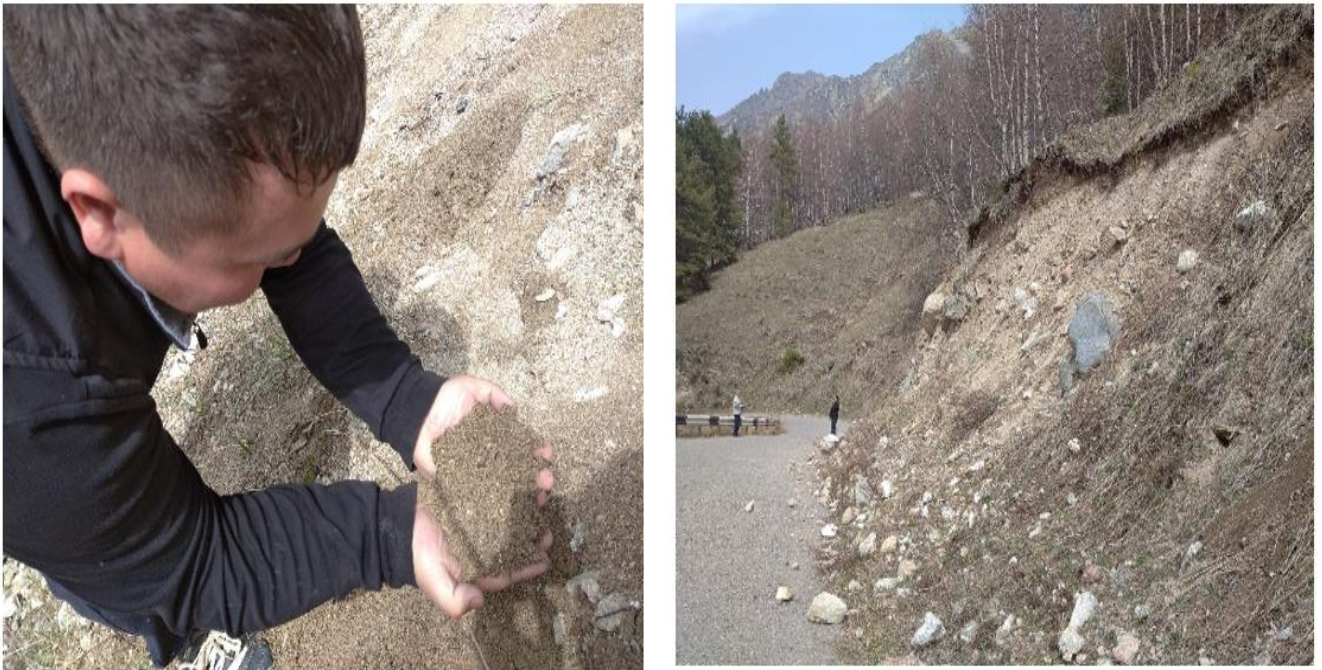
**Figure 11.**  
Weak soils of mountain slopes, creating a shear force on the base of the pavement.

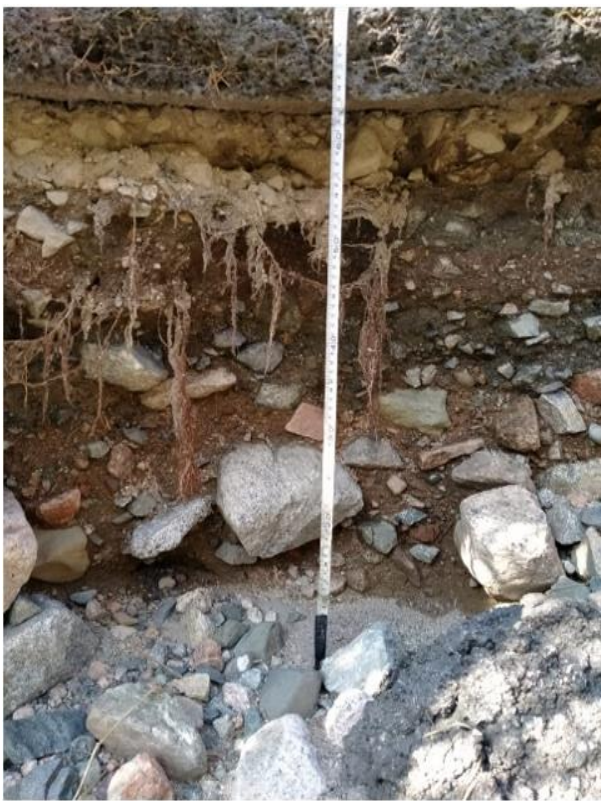
**Figure 12.**  
General type of erosion in 2021 (a) and in 2023 (b).

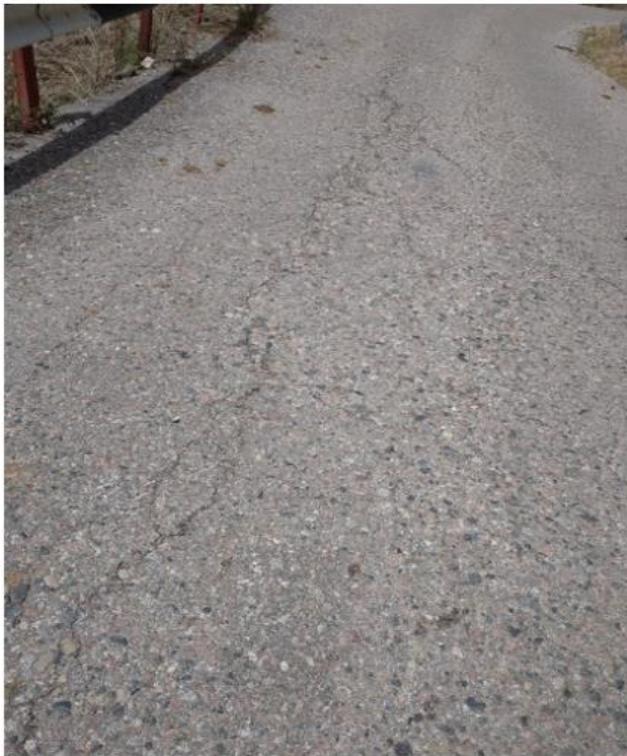
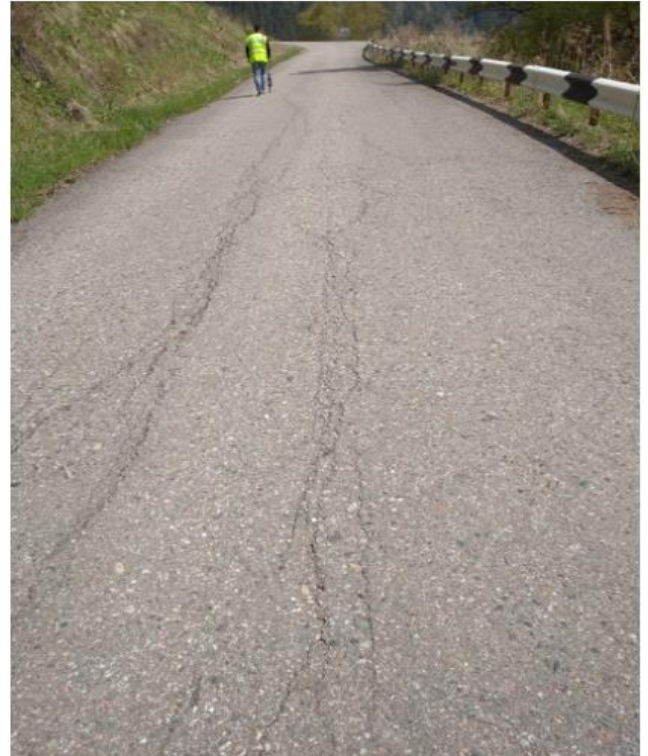
**Figure 13.**  
Longitudinal cracks in section No. 4.

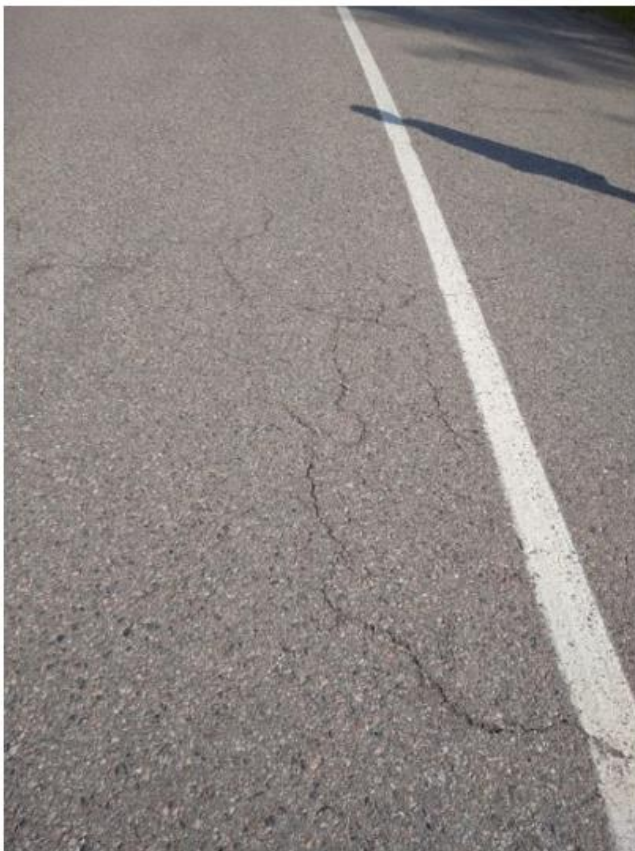
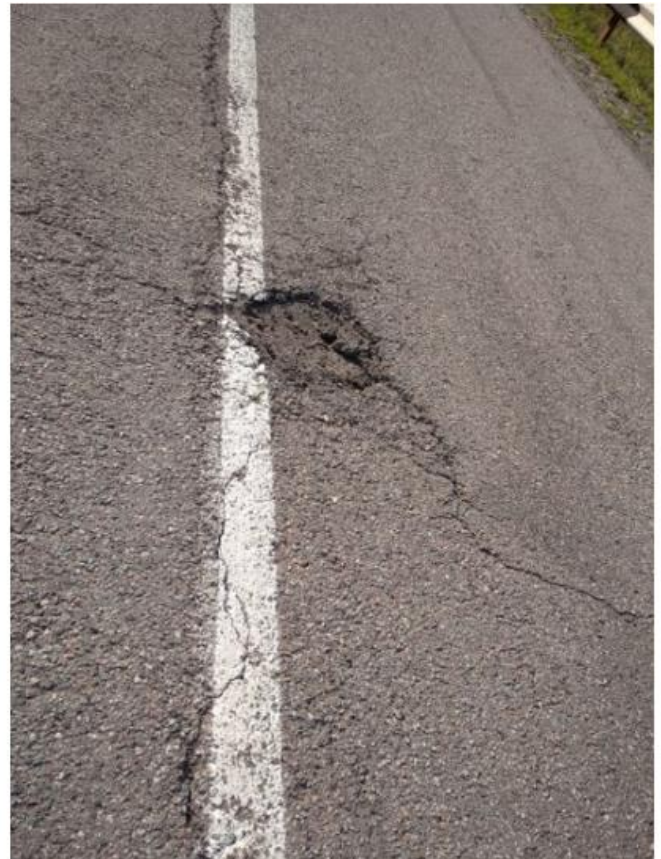
**Figure 14.**  
Small cracks and pits that appeared on the surface of the newly built site No. 5.

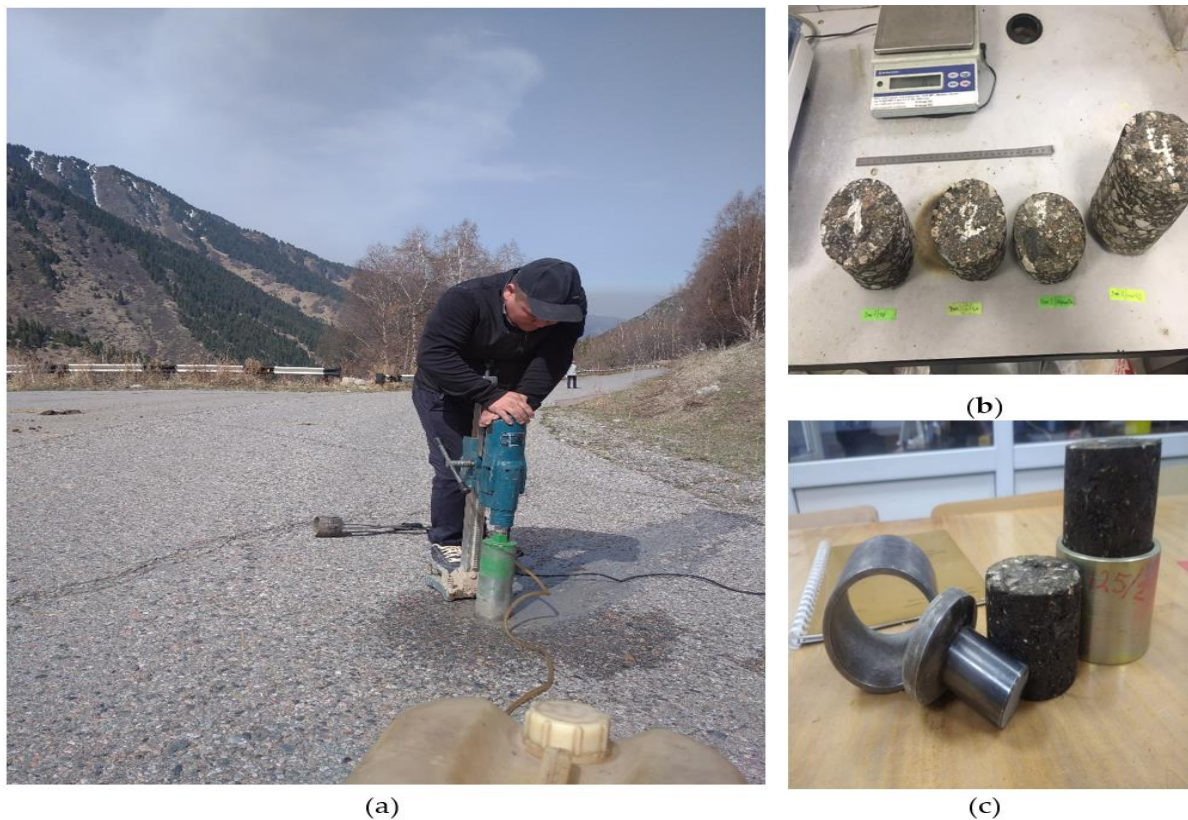
We extracted cylindrical cores through drilling to assess the physical and mechanical properties of the road surface (Figure 15 a, b). In the laboratory, two standard samples were prepared from the collected asphalt concrete samples (Figure 15 c). We conducted laboratory testing procedures in accordance with the guidelines provided in GOST [42]. The findings from the laboratory analysis of the physical and mechanical properties of asphalt concrete can be found in Table 8 and Figure 16.

**Figure 15.** Asphalt concrete samples: (a) sampling in the field; (b) samples from 4 sections of the road under study; (c) reference materials prepared in the laboratory.
