Drones as a tool for the sustainable conservation of heritage metal Structures

Rubén Rodríguez Elizalde

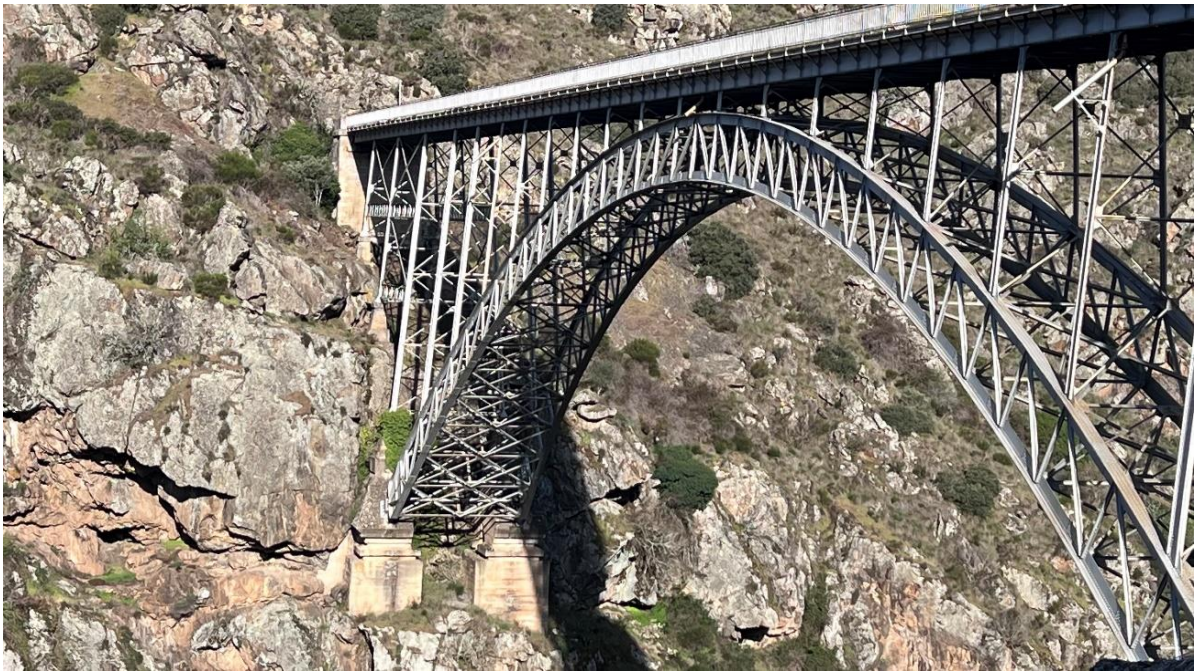
Figure 8.

Partial view of the bridge from the southern side (upstream side), showing the main arch and, in the background, the second abutment with its corresponding support trestles.

Stains produced by the discharge of water and other liquids through the drainpipes were also observed. At the time of the visit, these pipes were not long enough to discharge water away from the arch (a pipe can be seen in the center of the arch in Figure 8 and Figure 18).

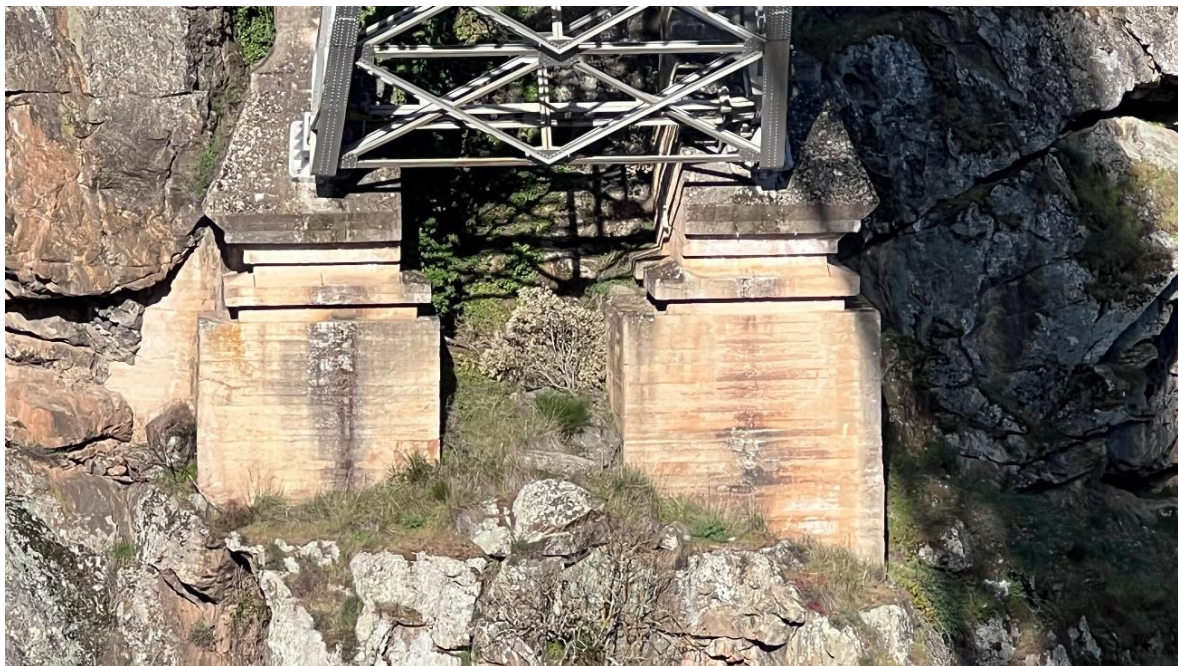
Figure 9.

Arch supports on direct concrete foundations near the second abutment.

Previous observations (Figure 9) had already indicated that, despite its century-old age, the concrete foundation elements presented a generally acceptable state of conservation, showing slight deterioration related to the material's durability, particularly due to runoff water. The action of runoff water was also the primary pathology observed on the abutment walls, where stains associated with moisture caused by the continuous process of surface runoff sliding down the wall face were detected (Figure 13).
